**Safety Edge<sub>SM</sub>**  
**Demonstration Project**  
**Little Divine Road in**  
**Johnston County,**  
**North Carolina**

Draft Field Report  
July 1, 2011

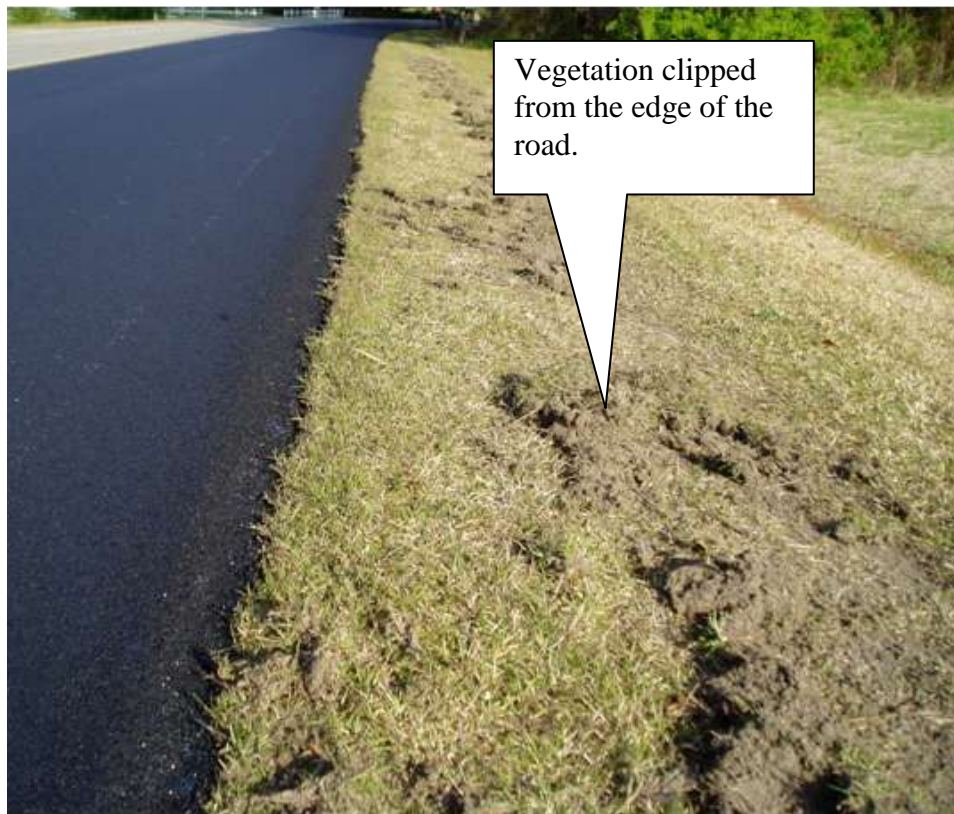
Isolated HMA patching and continuous brooming was conducted prior to paving. In limited locations the contractor used a small tractor equipped with a blade to clip soil/vegetation from the edge of the road, exposing the existing edge of pavement. Figure 8 shows some of the vegetation removed by the preparatory work. There were a few isolated areas where the soil/vegetation was slightly higher than the existing pavement and should have been clipped back farther to make room for the Safety Edge<sub>SM</sub>. It is important to clip the shoulders far enough back so the soil/vegetation does not become mix with the asphalt during paving.

Figure 8. Vegetation removed by clipping the edge of the existing pavement.

- It is important to clip the shoulders far enough back so soil/vegetation does not become mixed with the edge of the asphalt during paving. Clipping should be extended farther into the existing shoulder than with conventional overlays to allow extra width for the Safety Edge<sub>SM</sub>.

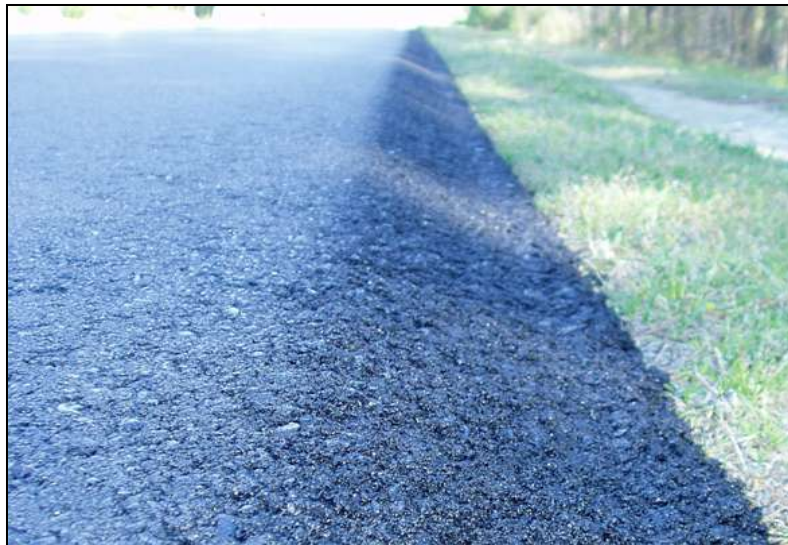
The Carlson device created a 0.25-inch vertical lip at the breakpoint of the edge as shown in Figure 9. The lip was compacted flat by the rolling operation. The texture of the finished slope face of the Safety Edge<sub>SM</sub> edge as shown in Figure 10 was nearly as smooth and sealed as the rest of the mat.

Figure 10. Texture of the Safety Edge<sub>SM</sub> slope face was nearly as smooth and sealed as the rest of the mat.

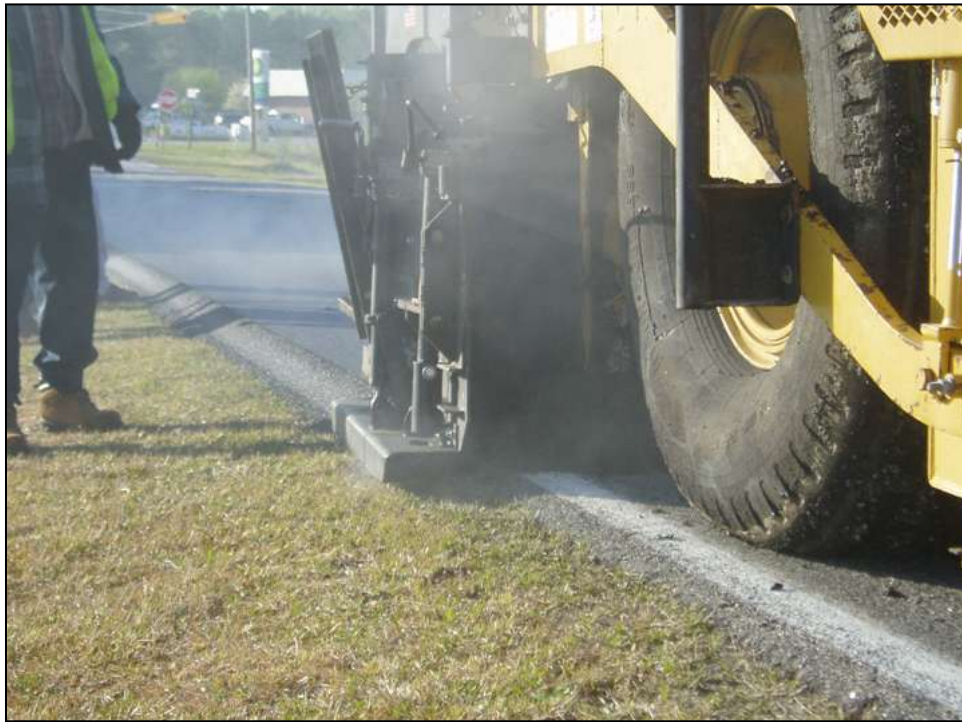
The Carlson device was set at a horizontal angle to the mat as shown in Figure 11 to add confining pressure to the edge as the paver moved forward. Figure 12 shows the Safety Edge<sub>SM</sub> directly behind the Carlson device.

Figure 11. Angled approach of the Carlson device.

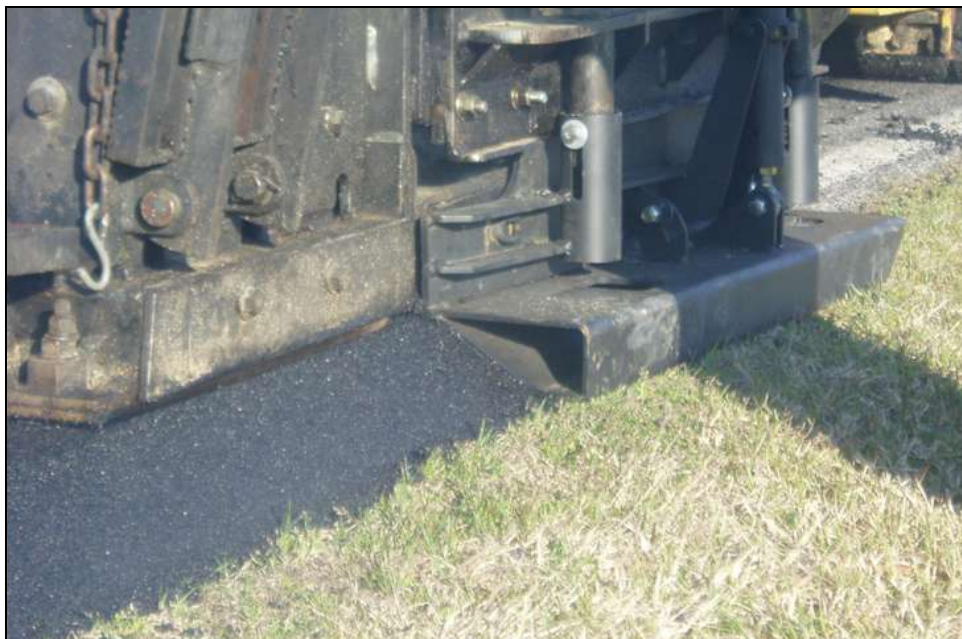
Figure 12. Safety Edges<sub>SM</sub> directly behind the Carlson device.
